Gold King Mine

Silverton, San Juan County, Colorado

0001/1408-01

## PHOTOGRAPH LOG

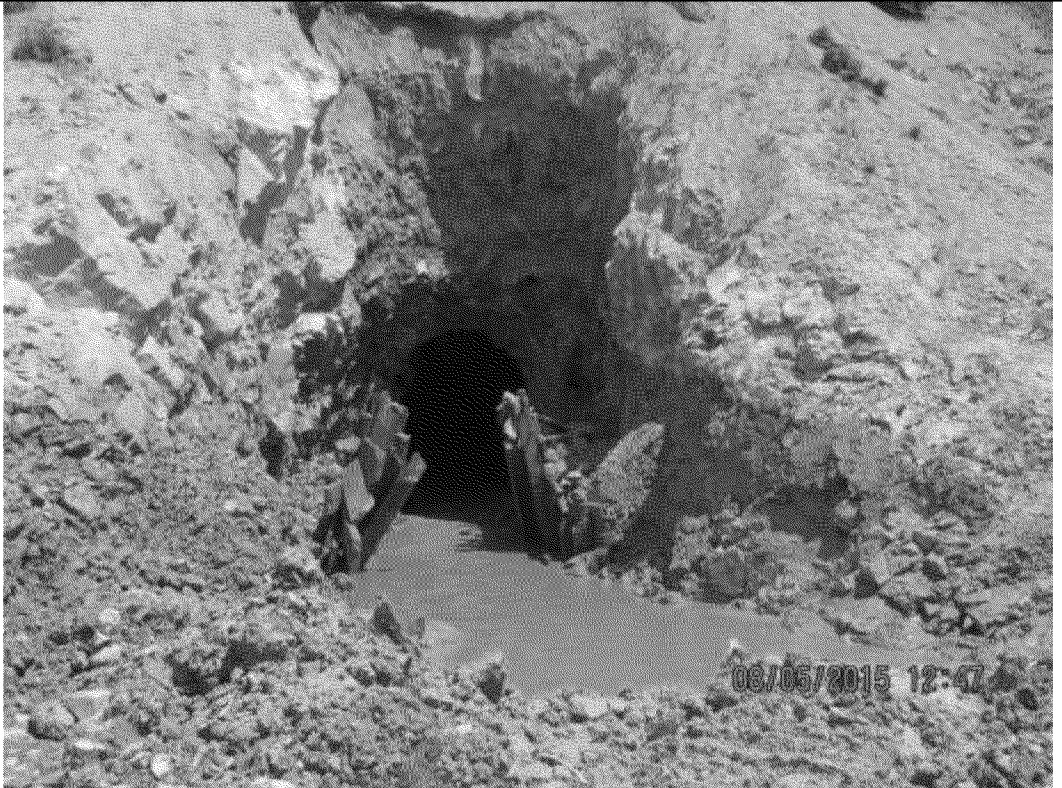
<b>Photo No.</b> <b>39</b>	<b>Date:</b> 08/05/2015

<b>Direction Photo Taken:</b>  North		
<b>Description:</b> No changes visible in adit structure or supports. Sloughing of materials inside the mine can be heard.		
<b>Photo No.</b> <b>40</b>	<b>Date:</b> 08/05/2015

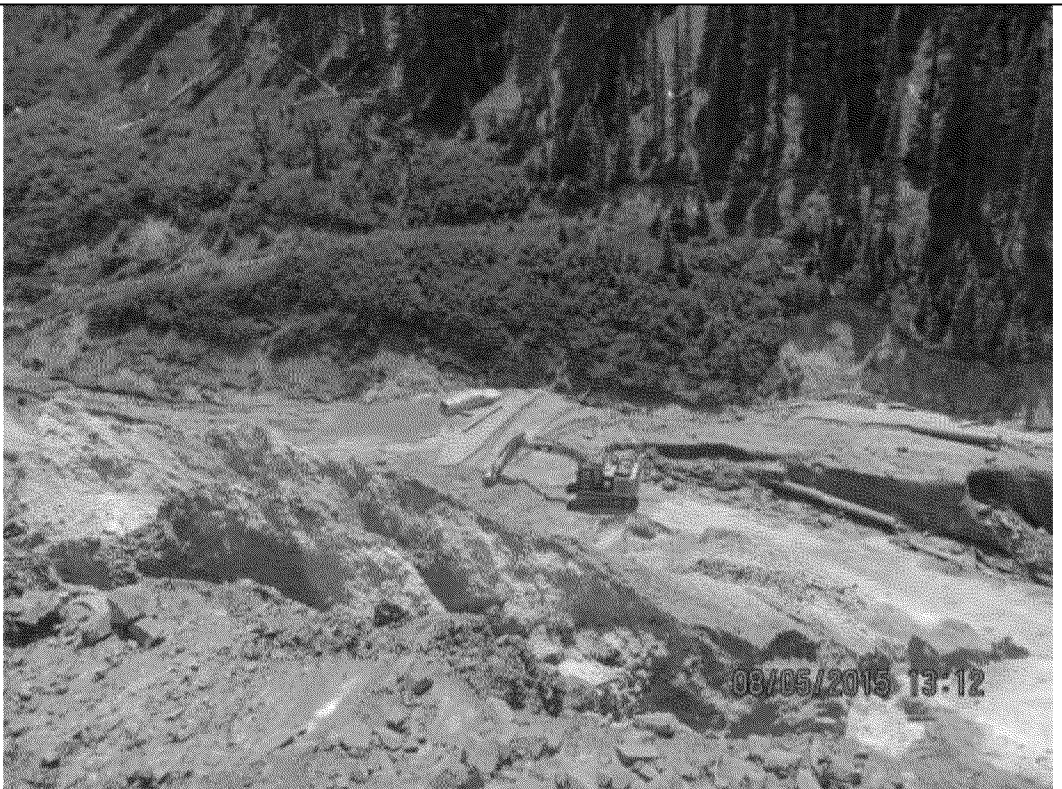
<b>Direction Photo Taken:</b>  South/Down		
<b>Description:</b> Excavator progresses to washed out North Fork crossing.

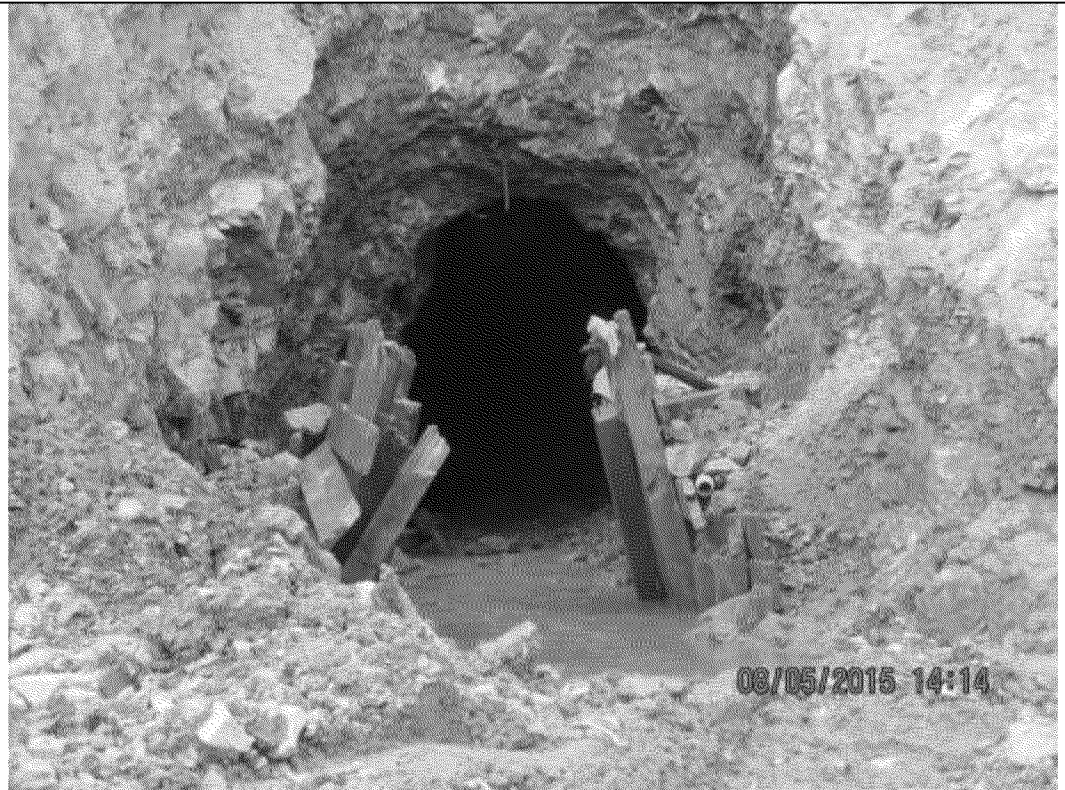
**Photo  
No.  
45**

Water levels lowering  
at adit entrance, no  
visible changes to  
structure.

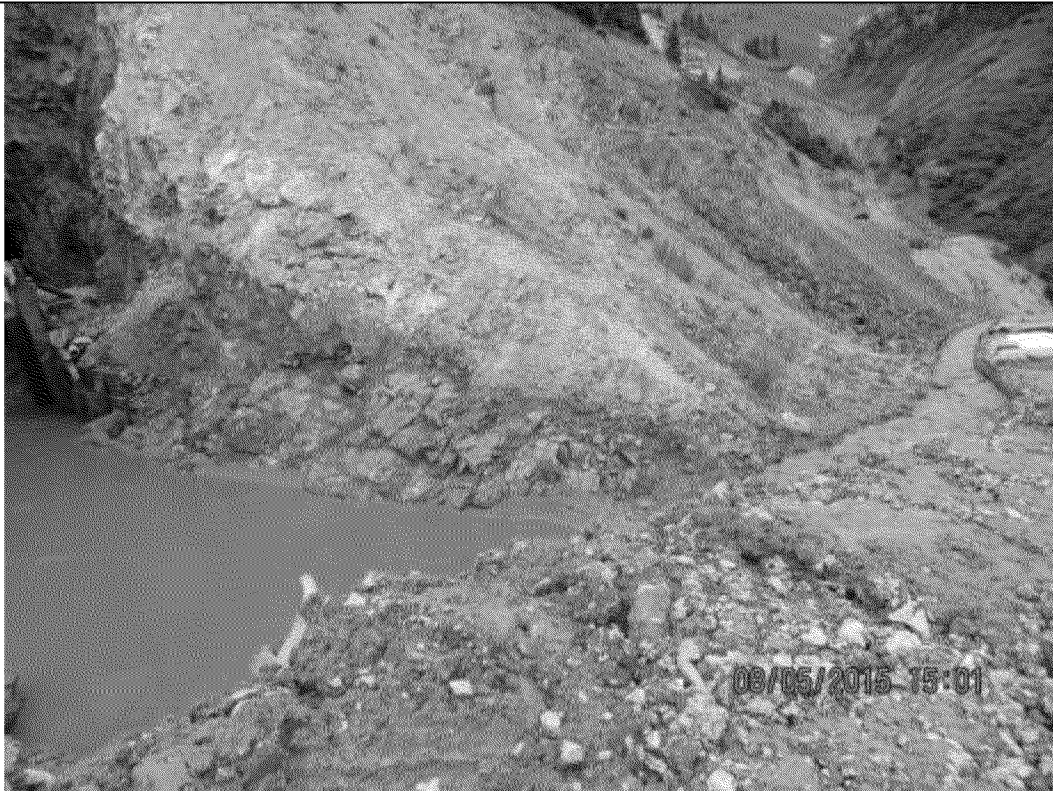
<b>Photo No.</b> <b>48</b>	<b>Date:</b> 08/05/2015

<b>Direction Photo Taken:</b>  Northeast		
<b>Description:</b> Flow path from adit, water flow appears to have stabilized around 1400.

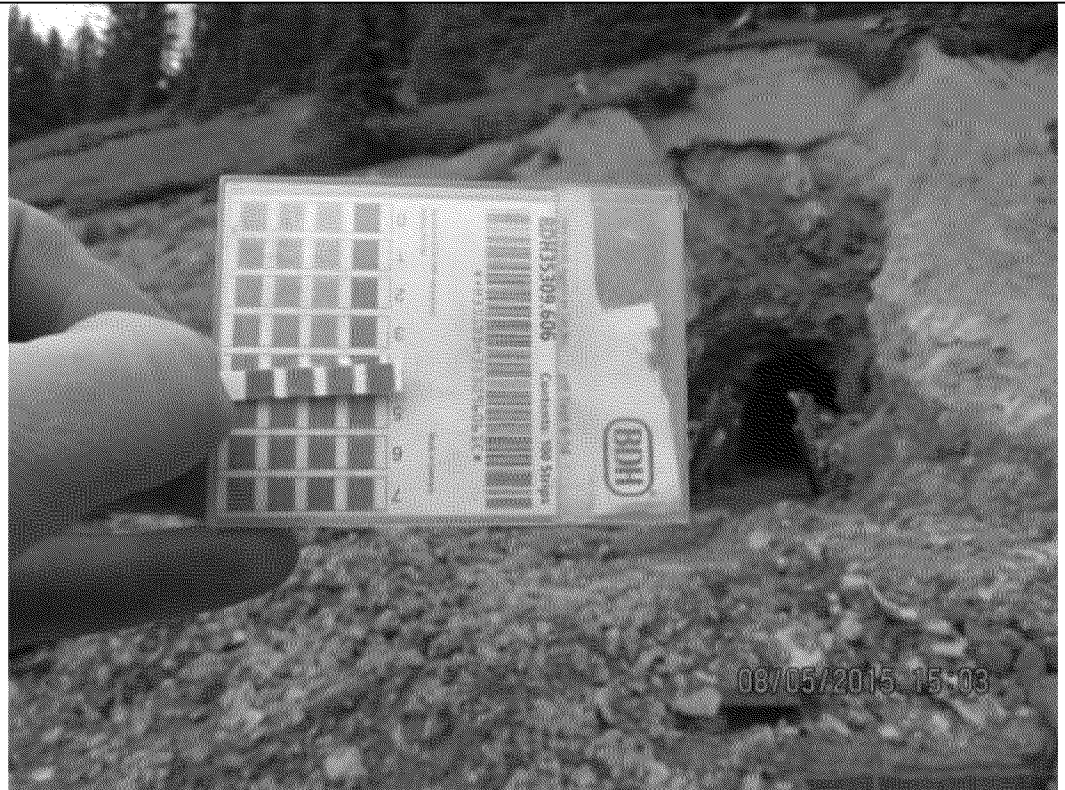
**Photo No.**  
**49**

pH measured at approximately 4.5.
